Summary table	
Site Name:	Cotmoor Solar Farm	
Project reference:	J.3180	
Site Address:	Land at Cotmoor Lane, Southwell, N	Nottinghamshire
Nearest Postcode:	NG25 0QZ	
Central Grid reference:	SK 67074 53226	
Local Planning Authority:	Newark and Sherwood District Cou	ncil
Relevant planning policies:	Amended Core Strategy (adopted 2	2019)
Statutory Controls:	Tree Preservation Order	Conservation Area
	None	None
Soil Type: (Source: BGS online soils	Superficial/Drift	Bedrock
map © NERC 2019)	None recorded	Gunthorpe Member
Topographical Survey:	Topographical Survey - 25240_06_1	70_01.1_MEC Geomatics
Site Layout:	JBM_20200616_19_3P_49.9MWp_I	Layout_A - 16/06/20
Notes:	None	
Report author:	Andrew Cunningham, Arboriculturis	st
Date of issue:	19th March 2020	
Revision:	Rev A - 26th June 2020 - Updated I	ayout

PROJECT NO:J.3180

COTMOOR SOLAR FARM

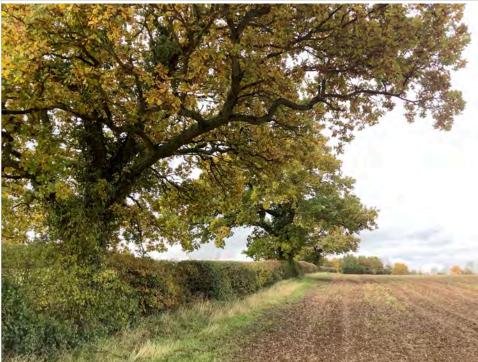
PHOTO 4: Looking north-west along moderate-quality hedgerow H8 towards high-quality individual trees T18-20.

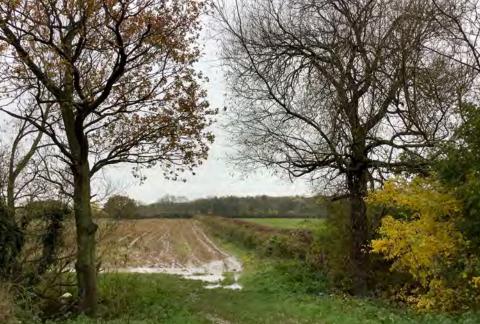
- 5.15. Hard surfacing in the form of the access track will be required within the RPA of retained trees T26 and T45. Within these locations, there are existing farm tracks. The tracks are in regular use and so compaction and

- disturbance is likely to have limited the root growth of adjacent trees into these areas. Installation of the new track will upgrade the existing surface by using crushed stone in the construction. The impact from these works is likely to have a minimal impact on the trees' overall health, and is therefore acceptable.
- 5.16. The RPAs of retained trees, including trees growing outside of, but adjacent to the site boundaries, can be adequately protected with protective barriers. A combined draft tree retention and removal and tree protection plan is included in section 5.
- 5.17. The proposal is feasible from an arboricultural perspective, and if carefully implemented according to an approved arboricultural method statement there would be no or only a low potential negative impact on the retained trees.

(right of centre). Note existing fam access between stems.

PHOTO 5: Looking south at moderate-quality trees T44 (left of centre) and T45 PHOTO 6: Existing access track to New Radley Farm in the northern section of the site. Note already compacted stone road surface.
